Addendum: Additions and Corrections to “Engine Tuning” article (Part III)

Clarification of Sept/Oct 2007 OMC Blitz “Engine Rebuilding” Vol. 27, Issue 5

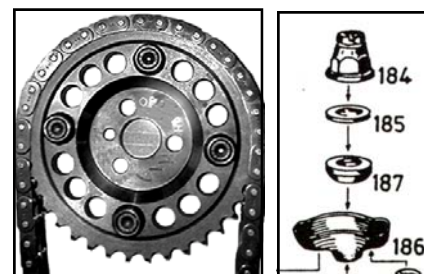
Camshaft Base Circle: (page 11)

The arrow on image (top of page 11) pointed too low. The corrected image is at right.
